CARROLL COUNTY WATER SYTEM IMPROVEMENT STUDY

**COUNTY OF CARROLL
OFFICE OF COMMISSIONERS
95 WATER VILLAGE ROAD
OSSIPPEE, NEW HAMPSHIRE**

DRAFT

DECEMBER 2021

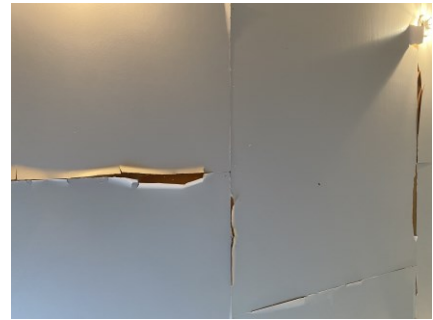
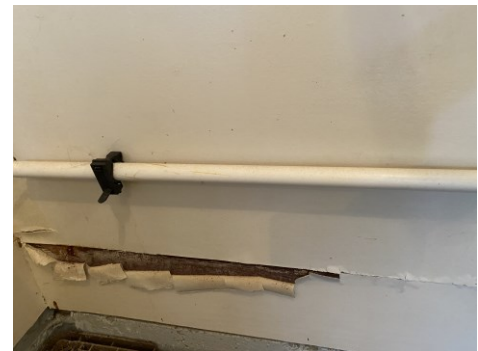
The 14 ft by 14 ft pump station building was constructed in 2001/2002 in conjunction with distribution improvements. The building houses chlorine injection, flow meters for the three source wells, and control equipment. A 1000 gal propane tank supplies a propane heater and 45 KW emergency generator.

The exterior of the wood-frame building is in good condition with no significant damage to the vinyl siding or metal roofing observed. The interior, however, shows significant evidence of moisture damage. Wall and ceiling panels are peeling in multiple places with the worst damage around the chlorine injection pump where a wall patch was added. The system operator indicated that the injection pump had leaked for a prolonged period of time causing chemical to spray onto the wall there. There is also evidence of corrosion damage to the propane heater, electrical wireway and on some panels.

4. Replace the SCADA system modem to a 5G model.
5. Replace areas of wall plywood as necessary, including insulation, to replace water/moisture damaged sections. Install FRP panels over all walls and ceiling.

6. Trim trees/branches from incoming electrical line
7. Replace propane heater
8. Assess condition of ventilation fan and louvers, and replace if necessary.

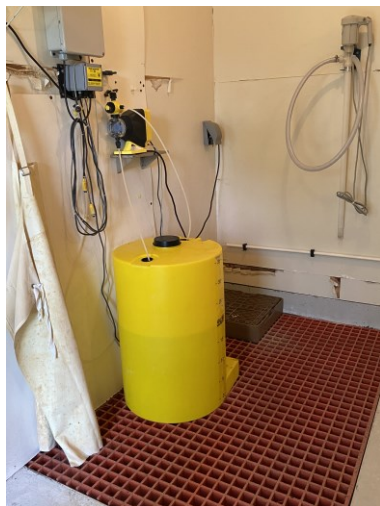
Chlorination System

The chlorination system consists of a 35 gallon storage tank and a wall mounted LMI positive displacement pump. Chlorine is transferred to the storage tank from 30 gallon drums via a drum pump. The system is interlocked to the well pumps to only operate when the wells are operational. Chlorine is injected into the pipeline leaving the meter building and going to the storage tank. A recessed floor area is present for secondary containment of the chemical area.

The chemical feed does not appear to be flow-paced, since the distribution flowmeter is currently inoperable. The operator reports that they manually adjust the pump stroke/speed based on sampling results. They report using 8-10 drums of 12.5% sodium hypochlorite per year. Chlorine residuals are monitored 2-3 times per week at a sample tap at the maintenance building.

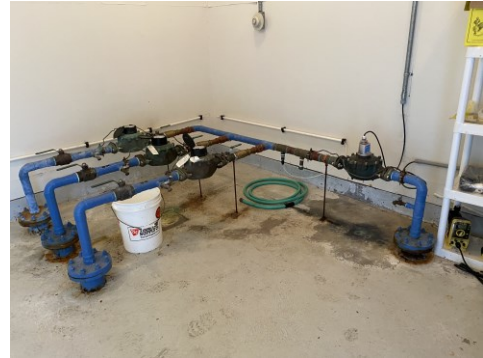
Flow meters

The pump station houses three Sensus SRII positive displacement source meters (one for each source), which are manually read and reported to NHDES on a monthly basis. A fourth Sensus SR ECR positive displacement meter, measures the combined flow to the storage tank and is equipped with an electronic reading device, which is connected to the Programmable Logic Controller/Supervisory Control and Data Acquisition PLC/SCADA system. Unfortunately, the flow meter that is attached to the SCADA system does not appear to be functional right now, so there are no flow readings available at SCADA. The SCADA consultant indicated that the Invensys Act Pact box between the flowmeter and PLC does not appear to be lit, so this may be the device that needs to be replaced.

1. Replace three positive displacement meters on source discharges.
2. Replace the positive displacement distribution meter with equipment to provide signal to SCADA (this is currently not operable).

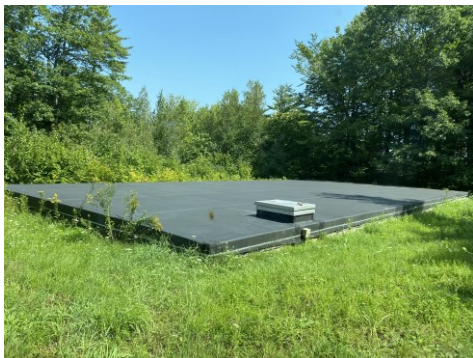
3.3 Storage Tank

Storage for the system is provided by a 200,000 gallon in-ground cast-in-place concrete tank with a pre-stressed hollow core precast concrete roof, covered by a rubber membrane roof with a 30" x 36" aluminum access hatch and ladder. The tank is located near the wells and meter building on a hill behind the complex, and feeds the system by gravity. Static pressures in the system at the complex are about 40-50 psi and in the village about 130-140 psi.

According to the operator, the exterior tank dimensions are 37 ft x 75 ft. The tank has two floor-to-ceiling baffle walls, each with a 5 ft opening. The 1999 Provan and Lorber report says the tank was constructed in 1987 and has a depth of 11 ft.

Underwater Solutions performed an inspection and tank cleaning in May of 2018 and found the tank to be in general good condition, with some concrete repair work needed on the exterior, and minor pipe cleaning/coating needed on the interior. What little sediment was found in the tank was removed during the inspection.

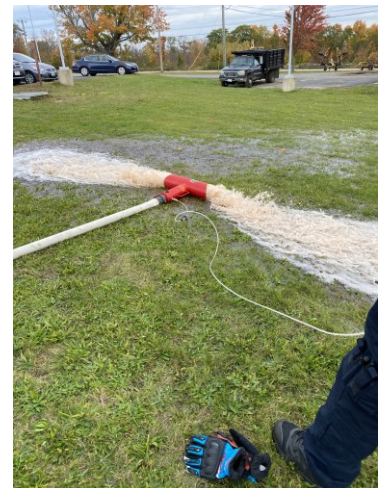
Fire Department flushing & testing apparatus

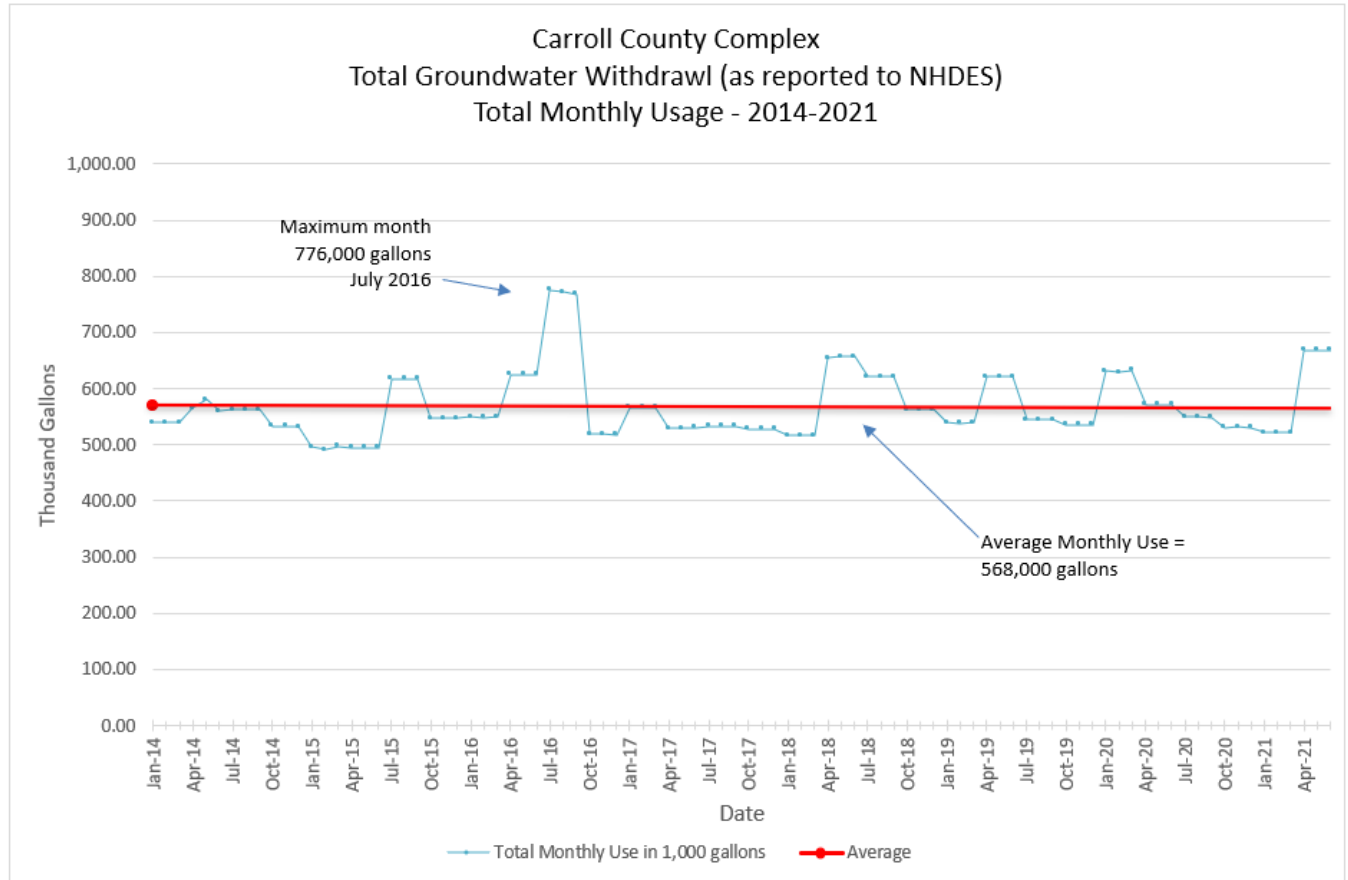
Figure 4-3 – Carroll County Total Groundwater Withdrawals

The individual source meters for the wells are read monthly and reported to NHDES, so daily metered flow data is not available. Monthly usage from each source was evaluated from Jan 2014 – June 2021, as shown in *Figures 4-2 & 4-3*.

The average daily use over the entire period was about 19,000 gpd. The maximum monthly use occurred in July 2016 with a monthly use of 776,000 gpd, which would yield a maximum daily flow of 26,000 gpd. The second highest usage was 668,000 gpd in April – May 2021, which would equate to a daily usage of about 22,288 in June 2021. Using these values as maximum daily demand would underestimate this figure, since it is not a measured daily flow, but an average over the month.

Approximate historic average daily use (ADD)	19,000 gpd
Approximate historic maximum daily use (MDD)	26,000 gpd

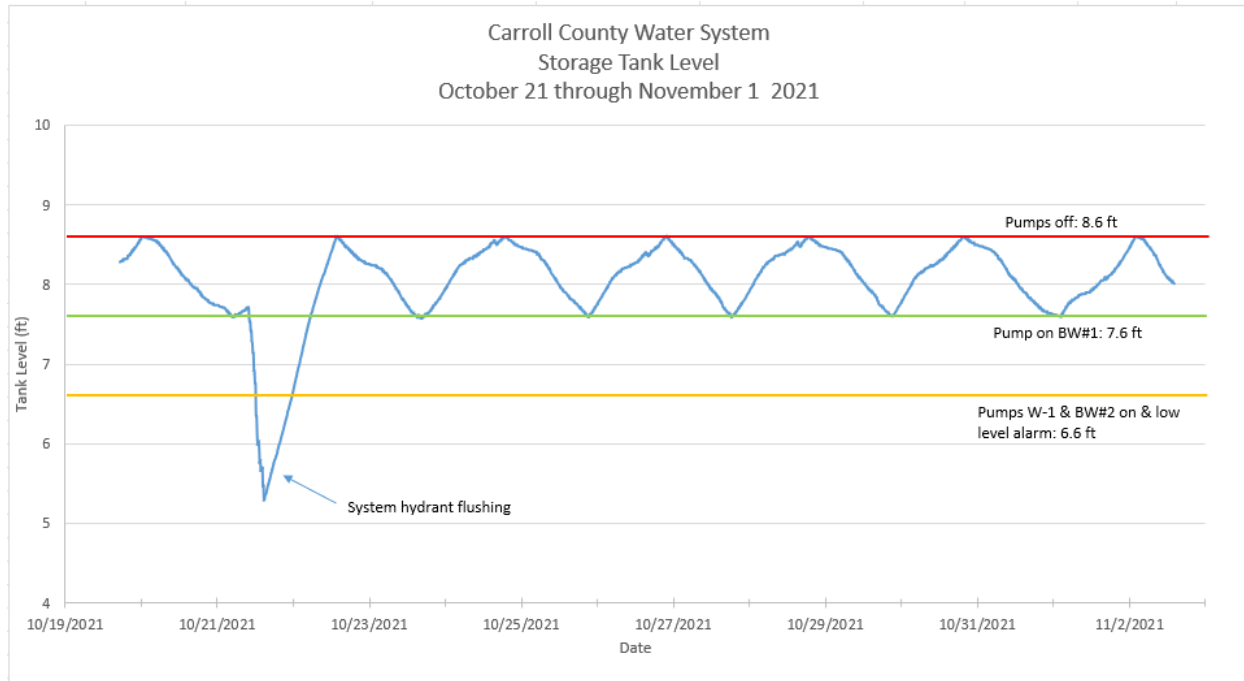
Figure 4-4 – Carroll County Storage Tank Level 2021

tank level data was analyzed during the period to help evaluate system usage and pumping rates. This information is illustrated in *Figure 4-4*.

On normal days (non-flushing), when BW#2 was called to run, it ran for 22.5 to 26.33 hours, with a tank fill rate of 12.4 to 14 gpm. Since the pump rate is believed to be about 24 gpm, we assume the system usage was about 10 to 11.6 gpm over the 24 hour period. Evaluating the draw cycle of the tank, when the well pumps are not operational, the tank drawdown ranged from 10.5 to 15.5 gpm (15,000-22,300 gpd). These values appear to be consistent with the previous calculations of about 19,000 gpd average daily use for the system.

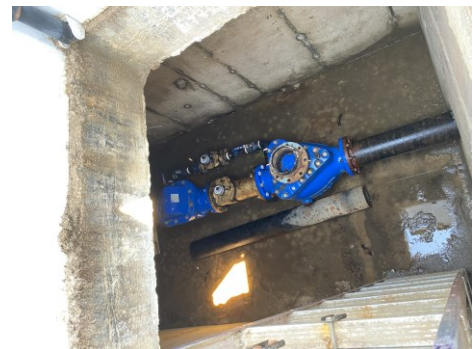
A meter vault is located near the maintenance building, which contains a compound meter. This meter was presumably intended to meter water leaving the Complex going to Ossipee Village. Downstream of this vault is a yard hydrant in the field between the Complex and Route 28 (for watering the blueberry bushes). It is unclear where the connections for the Maintenance Building and Jail

services are located, but they are believed to be from a branch main near the hydrant upstream of the vault.
